Code: DH-IPC-HDBW4231FP-A

IP VANDALPROOF CAMERA **DH-IPC-HDBW4231FP-A** S-0360B 3.6 mm DAHUA

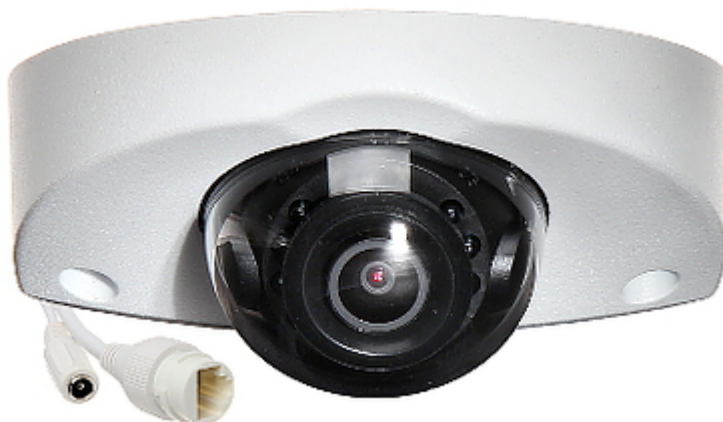
The camera has a very flat profile, it's only 51 mm out from the ceiling.

- The camera has a very flat profile, it's only 51 mm out from the ceiling.

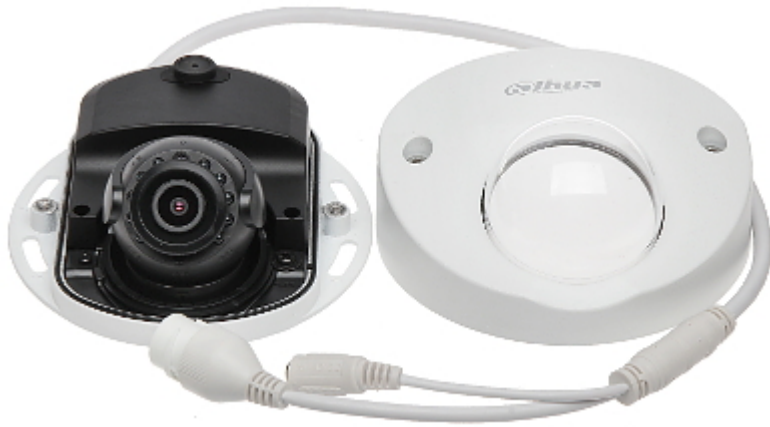
Camera view after remove the Dome cover:

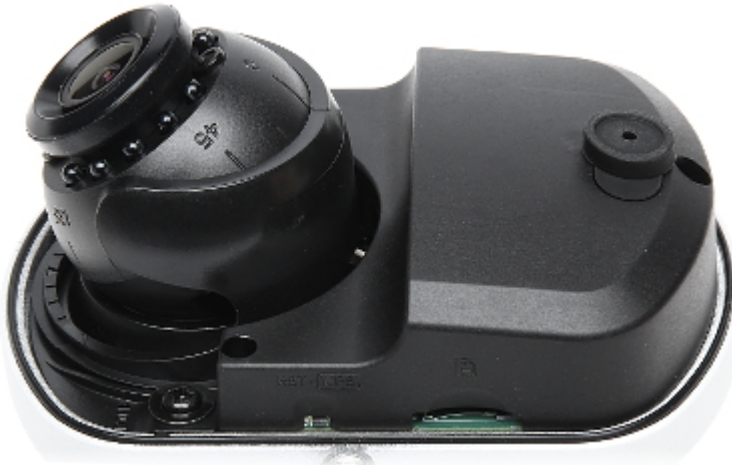
Memory card slot:

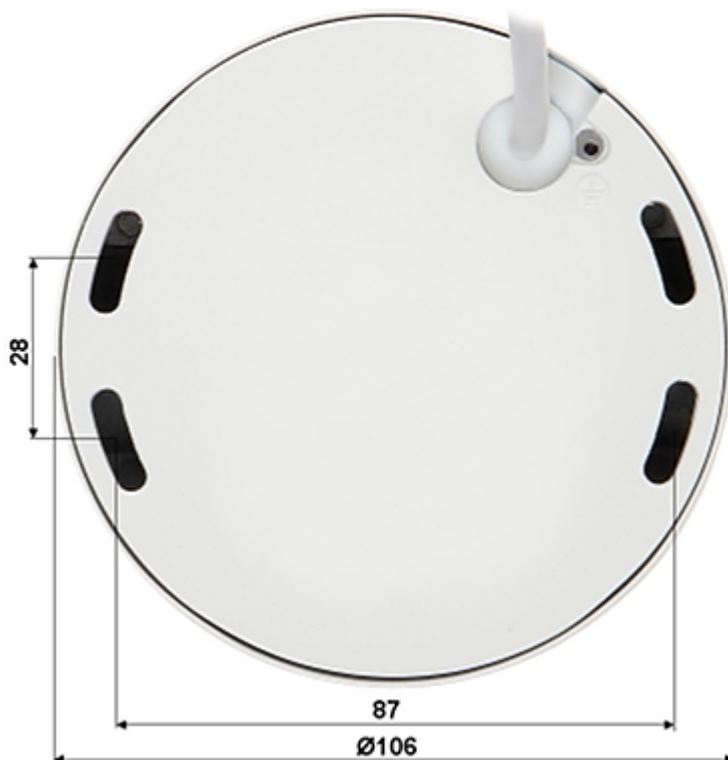
Mounting side view:

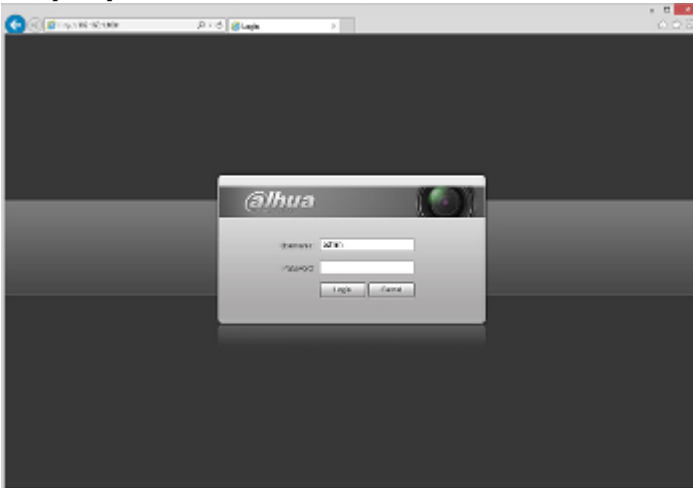
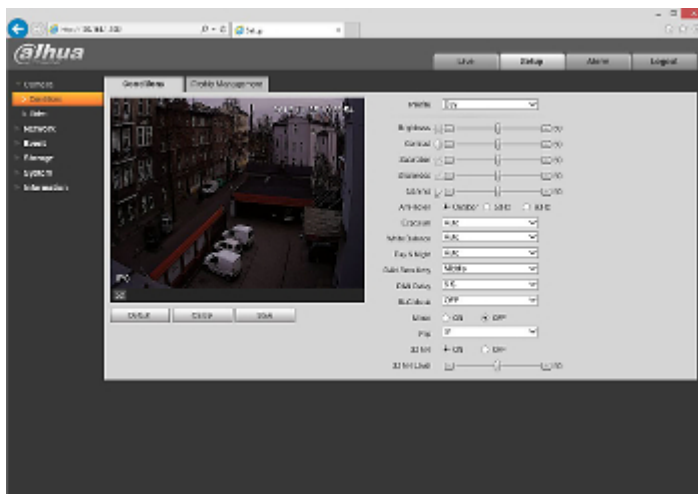
Example captures of device interface:

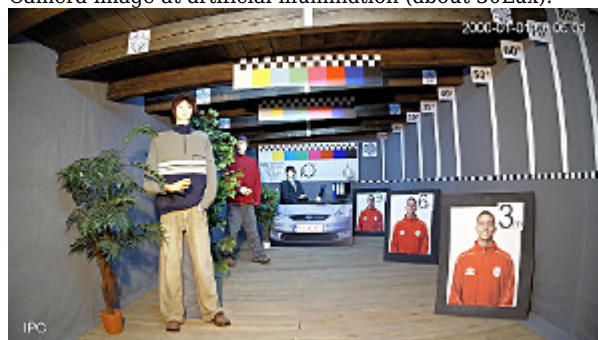
Camera image at artificial illumination (about 30Lux):

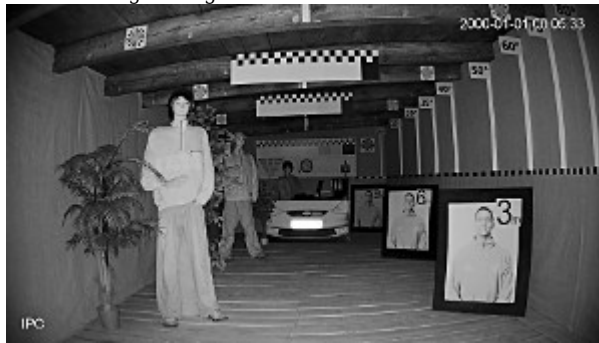
Camera image at night conditions with internal built-in IR illuminator on:

- Quite weak range of LED illumination.

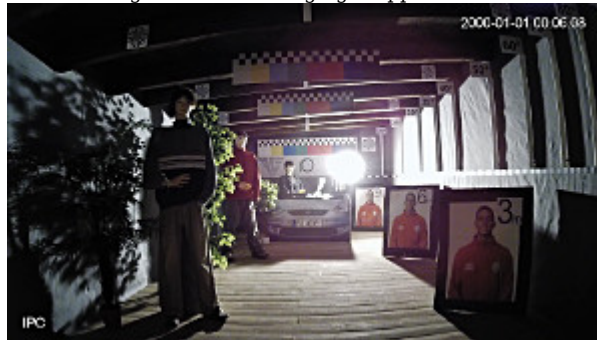
Camera image at direct strong light opposite to camera:
