Code: IPC-HDBW4231E-ASE-0360B

IP VANDALPROOF CAMERA **IPC-HDBW4231E-ASE-0360B** - 1080p, 3.6 mm DAHUA

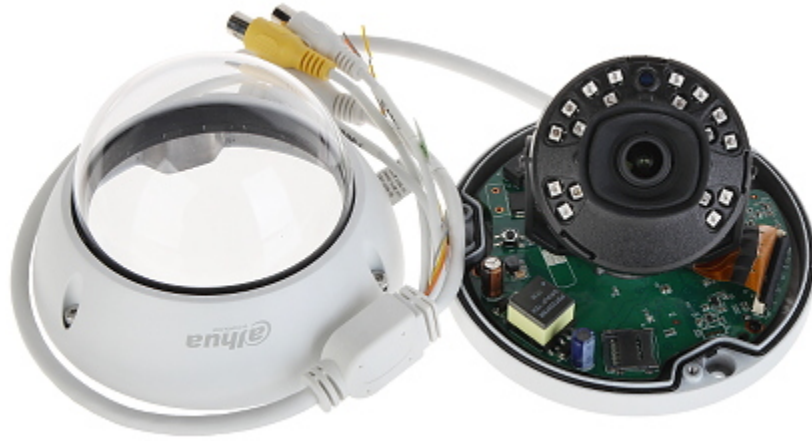
Camera view after remove the Dome cover:

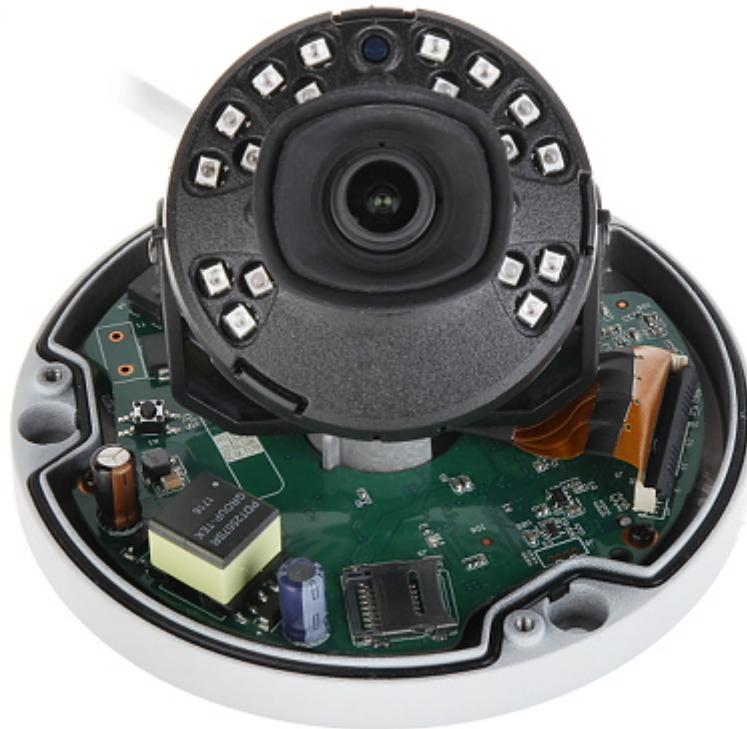
Micro SD card slot is located inside the camera:

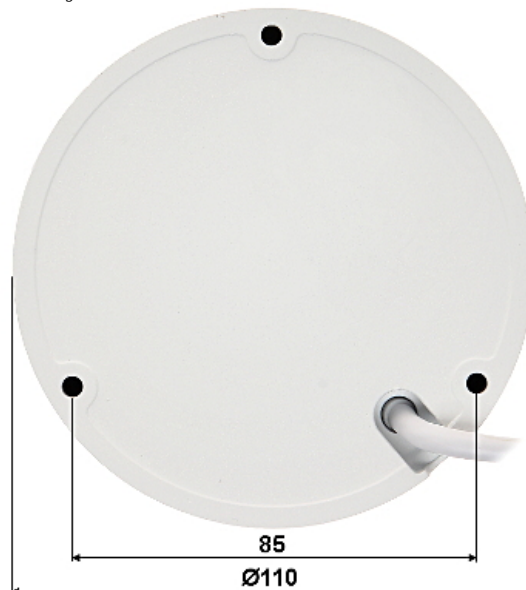
Mounting side view:

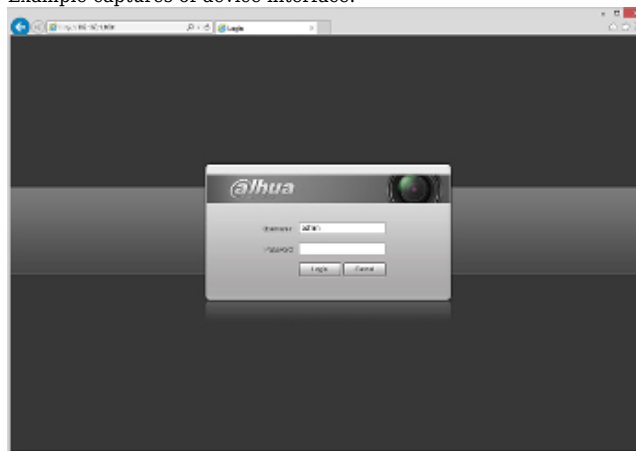
Example captures of device interface:

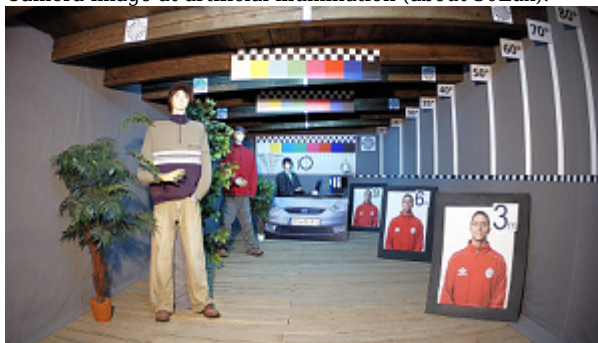
Camera image at artificial illumination (about 30Lux):

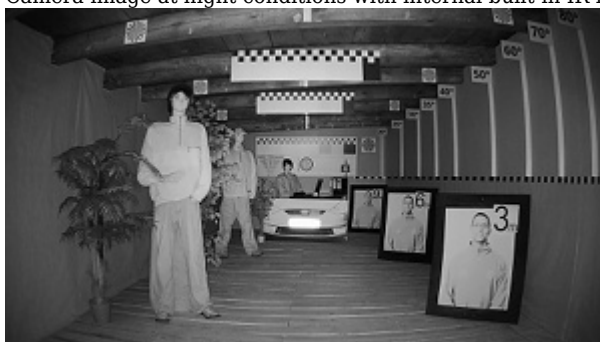
Camera image at night conditions with internal built-in IR illuminator on:

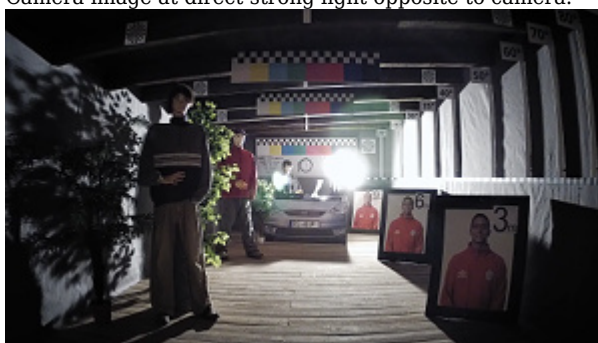
Camera image at direct strong light opposite to camera:
