Code: IPC-HDBW4231F-AS-0280B

# IP VANDALPROOF CAMERA **IPC-HDBW4231F-AS-0280B** 2.8 mm DAHUA

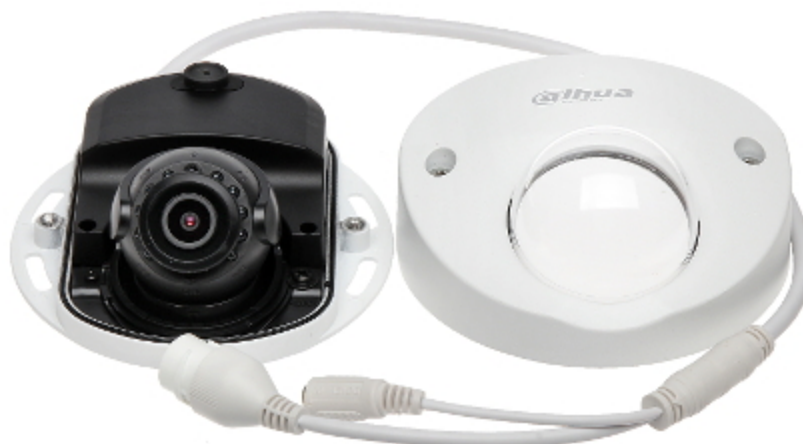
Camera view after remove the Dome cover:

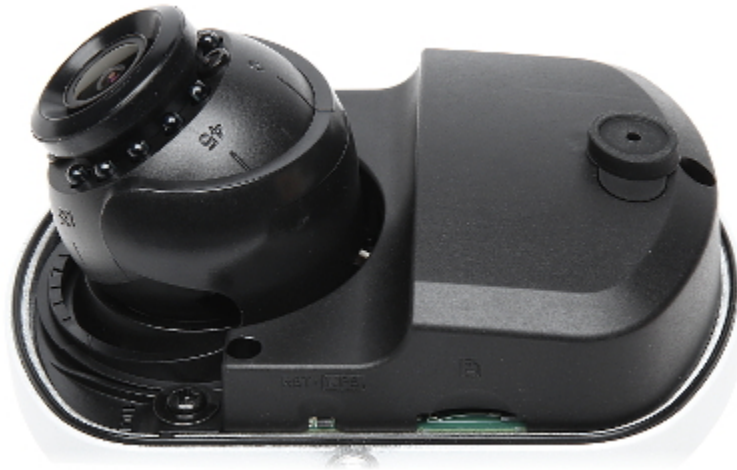
Memory card slot:

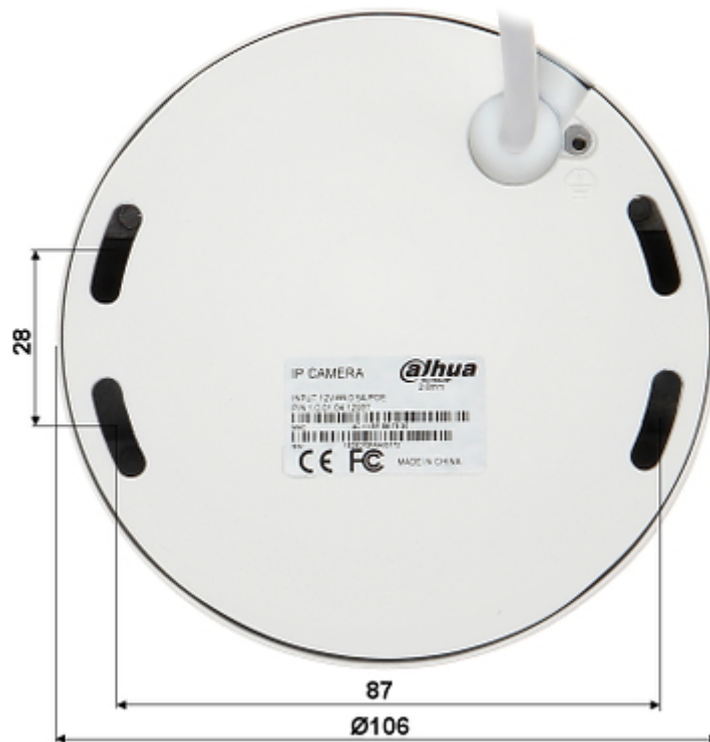
Mounting side view:

The camera has a very flat profile, it's only 51 mm out from the ceiling.

- The camera has a very flat profile, it's only 51 mm out from the ceiling.

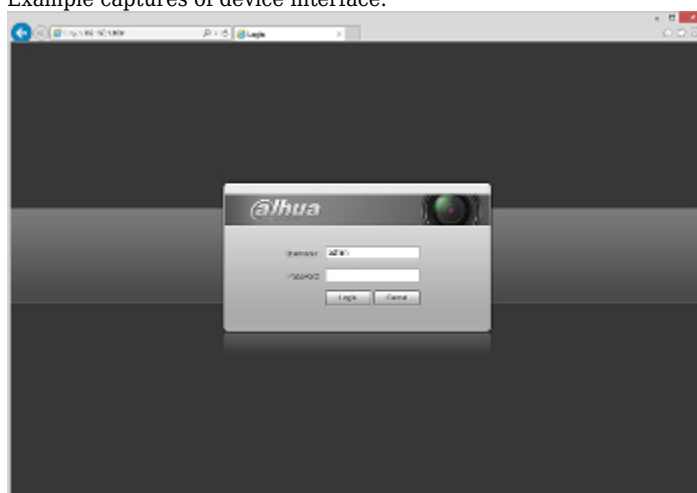
Example captures of device interface:

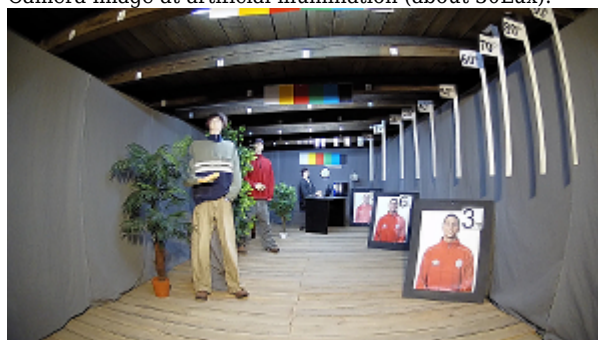
Camera image at artificial illumination (about 30Lux):

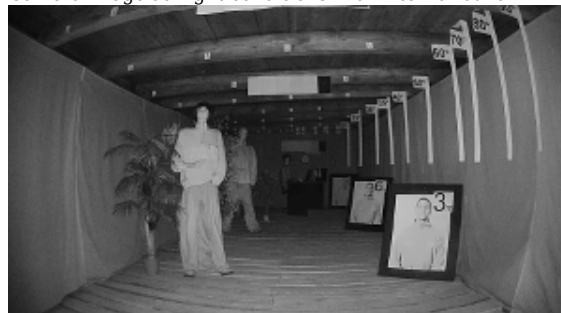
Camera image at night conditions with internal built-in IR illuminator on:

- Quite weak range of LED illumination.

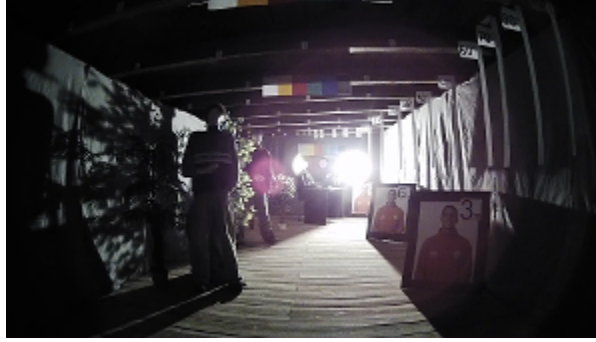
Camera image at direct strong light opposite to camera:
