Code: IPC-HDBW4231F-AS-0280B

# IP VANDALPROOF CAMERA **IPC-HDBW4231F-AS-0280B** - 1080p 2.8 mm DAHUA

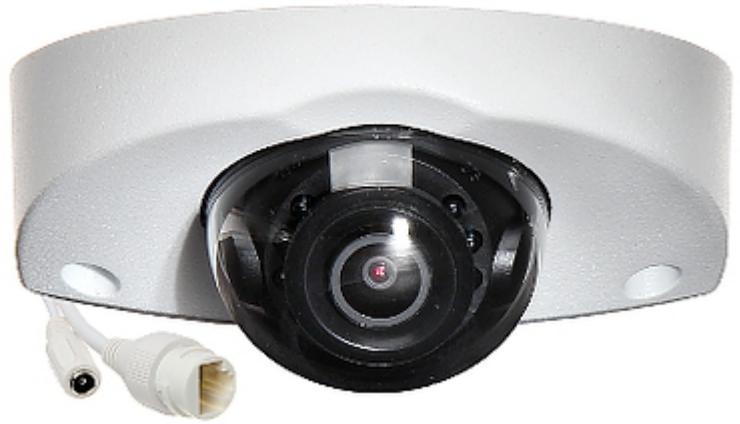
The camera has a very flat profile, it's only 51 mm out from the ceiling.

- The camera has a very flat profile, it's only 51 mm out from the ceiling.

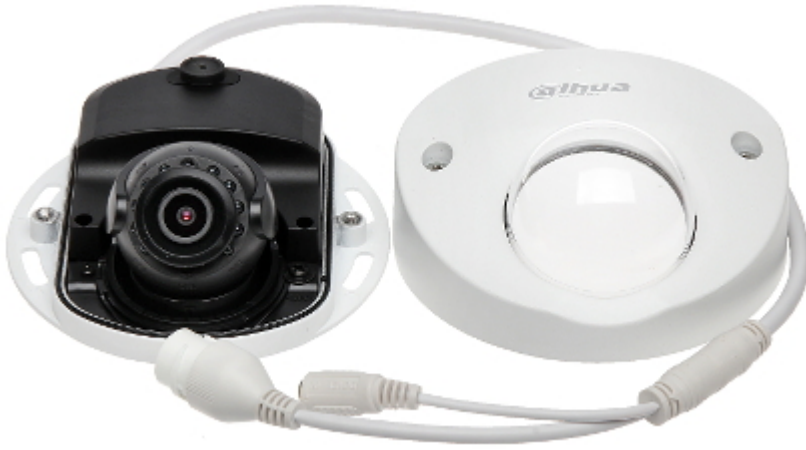
Camera view after remove the Dome cover:

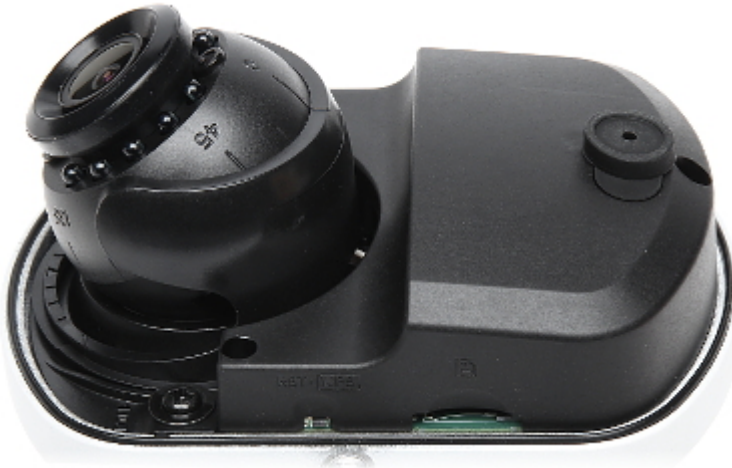
Memory card slot:

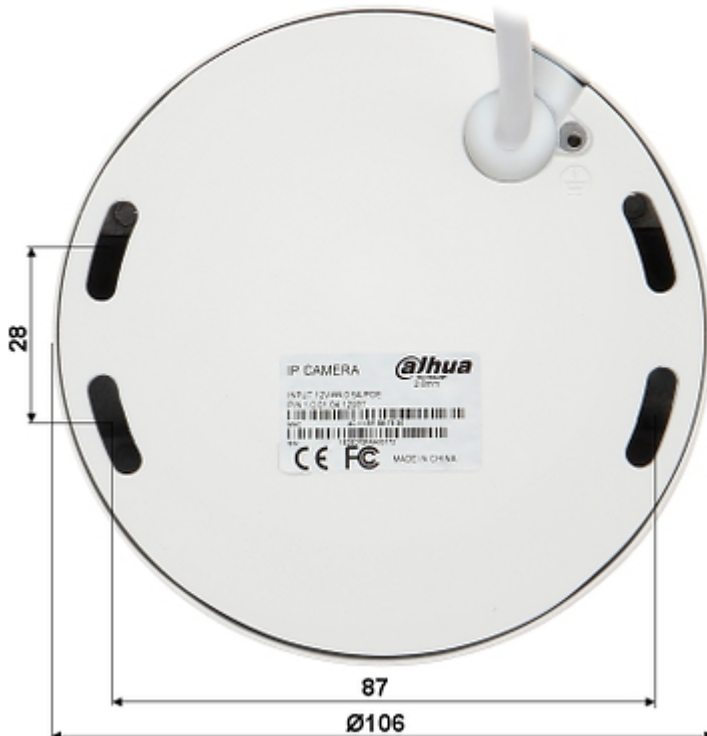
Mounting side view:

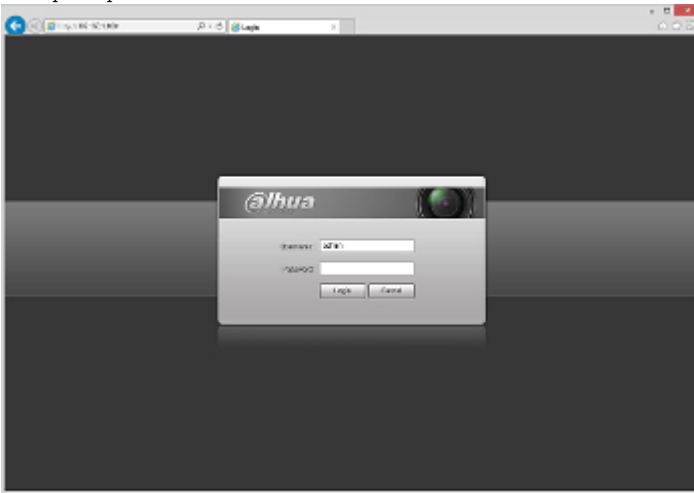
Example captures of device interface:

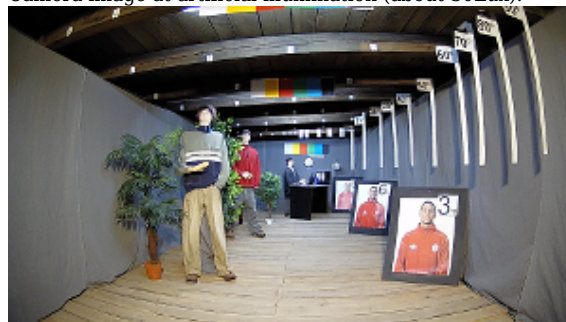
Camera image at artificial illumination (about 30Lux):

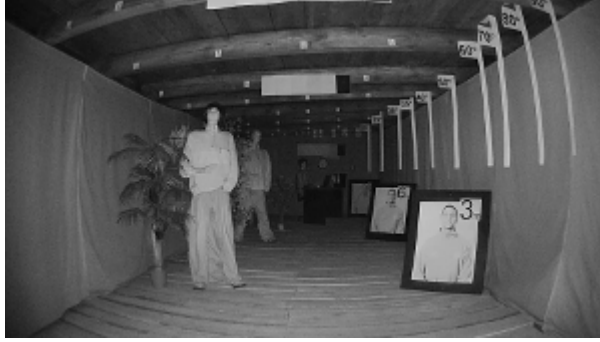
Camera image at night conditions with internal built-in IR illuminator on:

- Quite weak range of LED illumination.

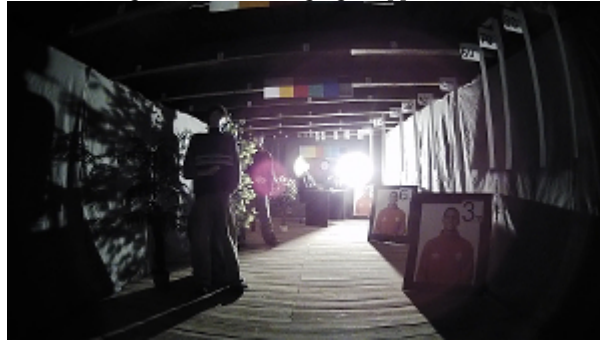
Camera image at direct strong light opposite to camera:
