Code: HAC-HDBW3802E-Z-3711
HD-CVI, PAL VANDALPROOF CAMERA **HAC-HDBW3802E-Z-3711** - 8.3 Mpx, 4K UHD 3.7 ... 11 mm - MOTOZOOM DAHUA

Megapixel camera with 1/2" CMOS sensor and HD-CVI (High Definition Composite Video Interface) / PAL. The HD-CVI interface allows to transmission of analog,

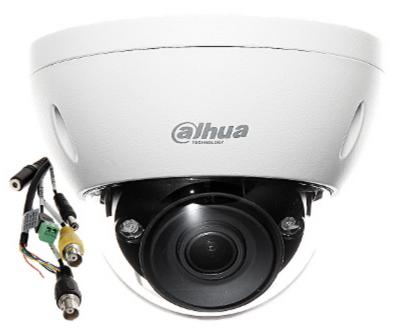
The used motozoom lens with 3.7 ... 11 mm focal length allows to remote view angle adjustment.

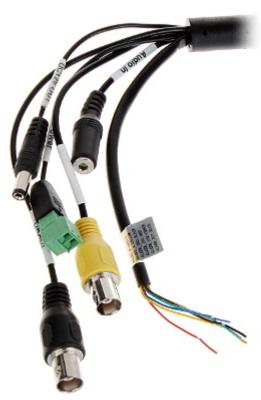
Connectors view:

Connectors description:
