Code: IPC-HDBW4231E-ASE-0360B
IP VANDALPROOF CAMERA IPC-HDBW4231E-ASE-0360B - 1080p, 3.6 mm DAHUA

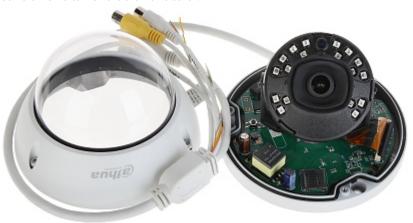
Camera view after remove the Dome cover:

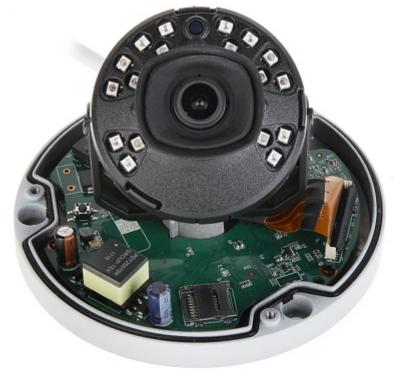
Micro SD card slot is located inside the camera:

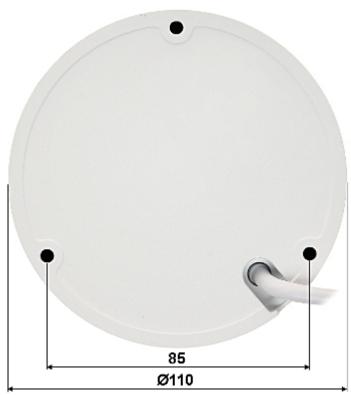
Mounting side view:

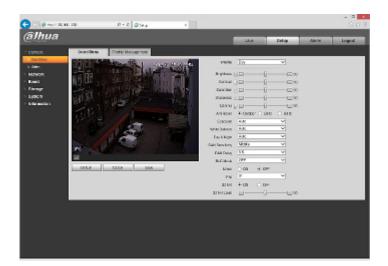
Example captures of device interface:
