Code: IPC-HDBW4231E-ASE-0280B IP VANDALPROOF CAMERA **IPC-HDBW4231E-ASE-0280B** - 1080p 2.8 mm DAHUA

IP camera with efficient $\rm H.264$ / $\rm H.265$ image compression algorithm for clear and smooth video streaming at maximal resolution of 1080p.

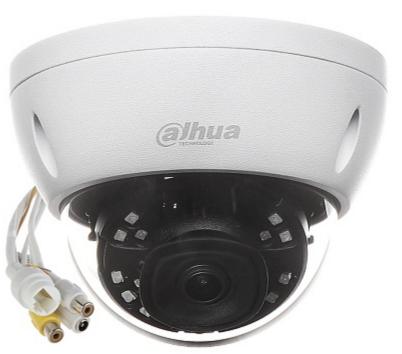
Thanks to the "Starlight" technology used, the camera only needs very low lighting to obtain a clear color image.
