Code: IPC-HDBW4231E-AS-0360B
IP VANDALPROOF CAMERA IPC-HDBW4231E-AS-0360B - 1080p 3.6 mm DAHUA

IP camera with efficient $\rm H.264$ / $\rm H.265$ image compression algorithm for clear and smooth video streaming at maximal resolution of 1080p.

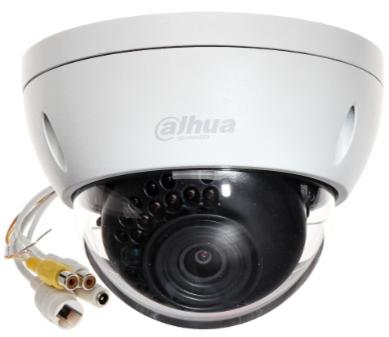
PoE powering possibility, compatible with the 802.3af standard makes the device more universal and easier to install.

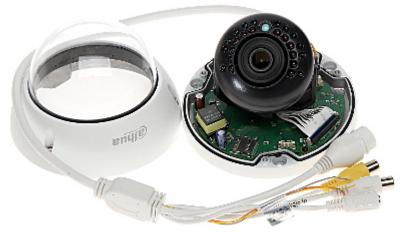
Camera view after remove the Dome cover:
